PRESSURE INJURY PREVENTION

Arjo Support Surface Range

How cover fabric impacts the clinical performance and infection control properties of a support surface

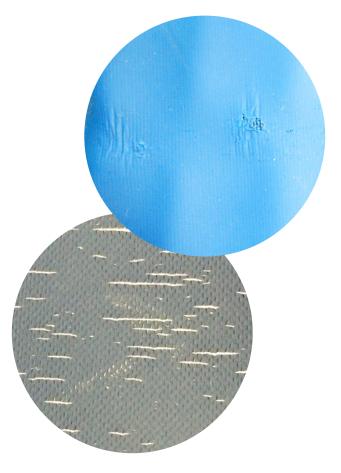
Magnified view of mattress covers damaged by chemicals and abrasion where "strikethrough" damage is starting to occur*

Even when mattress covers are welded their performance can sometimes be compromised due to damage from cleaning. Many different chemicals with varying strengths are used in cleaning solutions, which are not always rinsed away thoroughly after the cleaning process, and sometimes the covers are not aired well to dry off completely. These are known to be the main causes of cover 'strikethrough', when tiny microscopic cracks appear in the mattress cover. Strikethrough damage can be difficult to spot with the naked eye, but once they occur they may allow bodily fluids like sweat and urine to pass through the cover and contaminate the inner mattress.

Preventing strikethrough from occurring can be a challenge with many of the vigorous cleaning regimes that are in place in healthcare facilities. Selecting a cover fabric cover that is breathable, but also has the strength to withstand abrasive chemical cleaning would provide a clear advantage in supporting infection control and the clinical performance of your support surface.
